DEFENCELL BARRIERS FOR FLOOD CONTROL

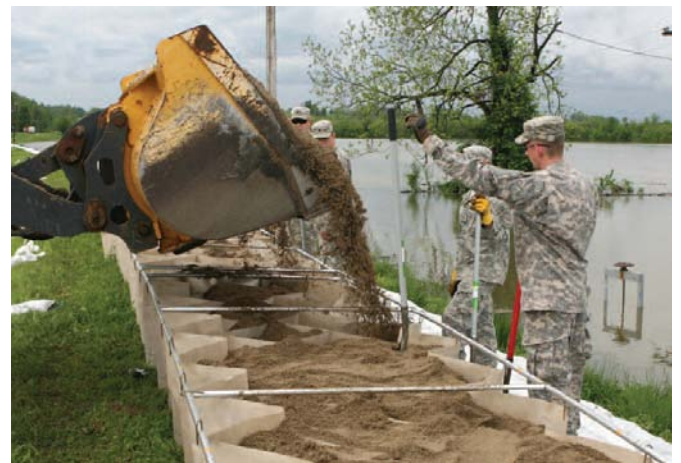
ERDC TESTING

DEFENCELL barriers underwent successful testing by the US Army Corps of Engineers at their Engineer Research and Development Centre in Vicksburg MS in November 2010 and passed all aspects of the testing procedure including static testing, wave action and impact tests. DEFENCELL was shown to be an effective, easy to install/remove, resilient and cost effective solution to flood protection. Further details are shown in the table overleaf.

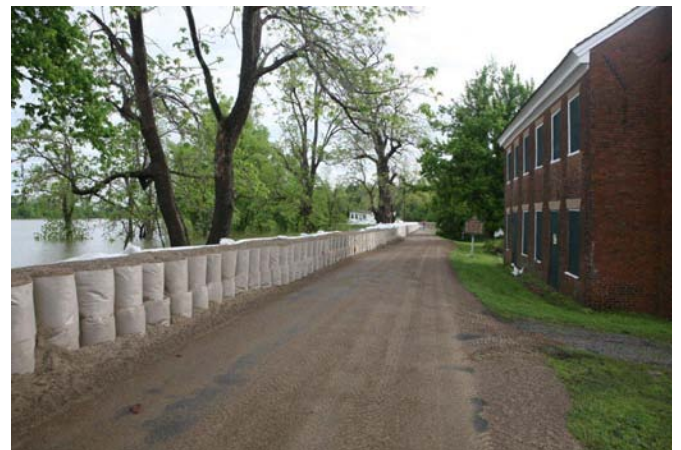
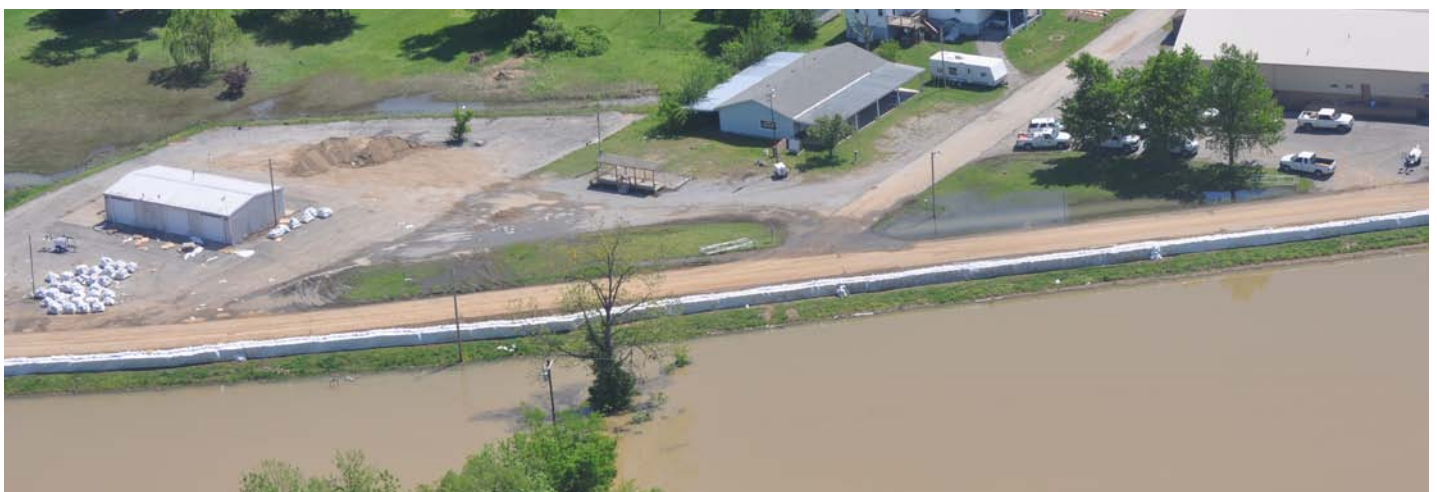
Over the next 34 workable hours over a mile of DEFENCELL Flood Walls were installed, 700+ units were filled, stacked two units high to help raise the town levee by one metre to meet the pending flood.

Within 24 hours of receiving a call from the USACE, DEFENCELL delivered three miles Flood Wall units that, once installed, would provide almost four feet of additional flood protection height to a key stretch of the levee in Smithland. As a testament to DEFENCELL's ease of use, within an hour of delivery to Smithland small teams were able to start placing, connecting and filling, the DEFENCELL Flood Wall systems, and within the first three hours, they achieved an installation rate of 20+ units per hour (equal to over 22,000 sandbags).

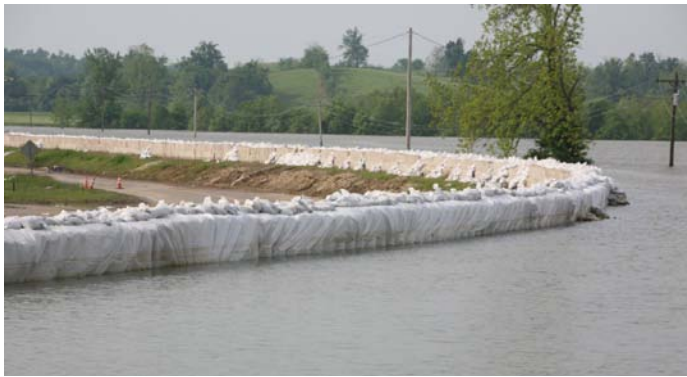
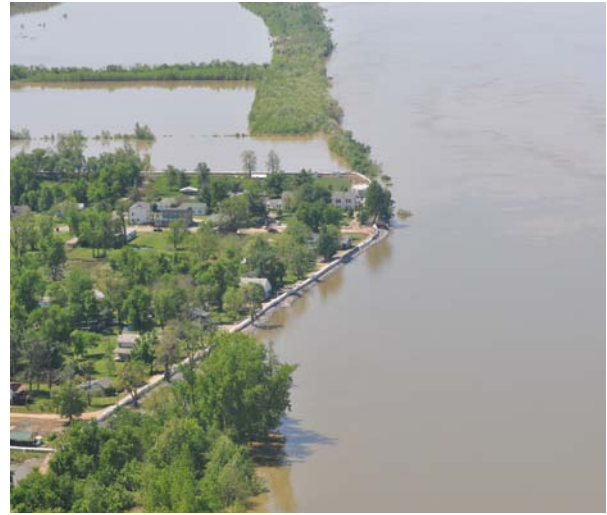
During the next ten days the river rose to the top of the wall and continued to threaten the town. The DefenCell barriers remained solid and additional barriers were installed to protect 'boils' and leaks from weak areas of the levees.
