Mechanical &
Electrical Services

Case Study

Manway Chamber

MoD Site, Borden

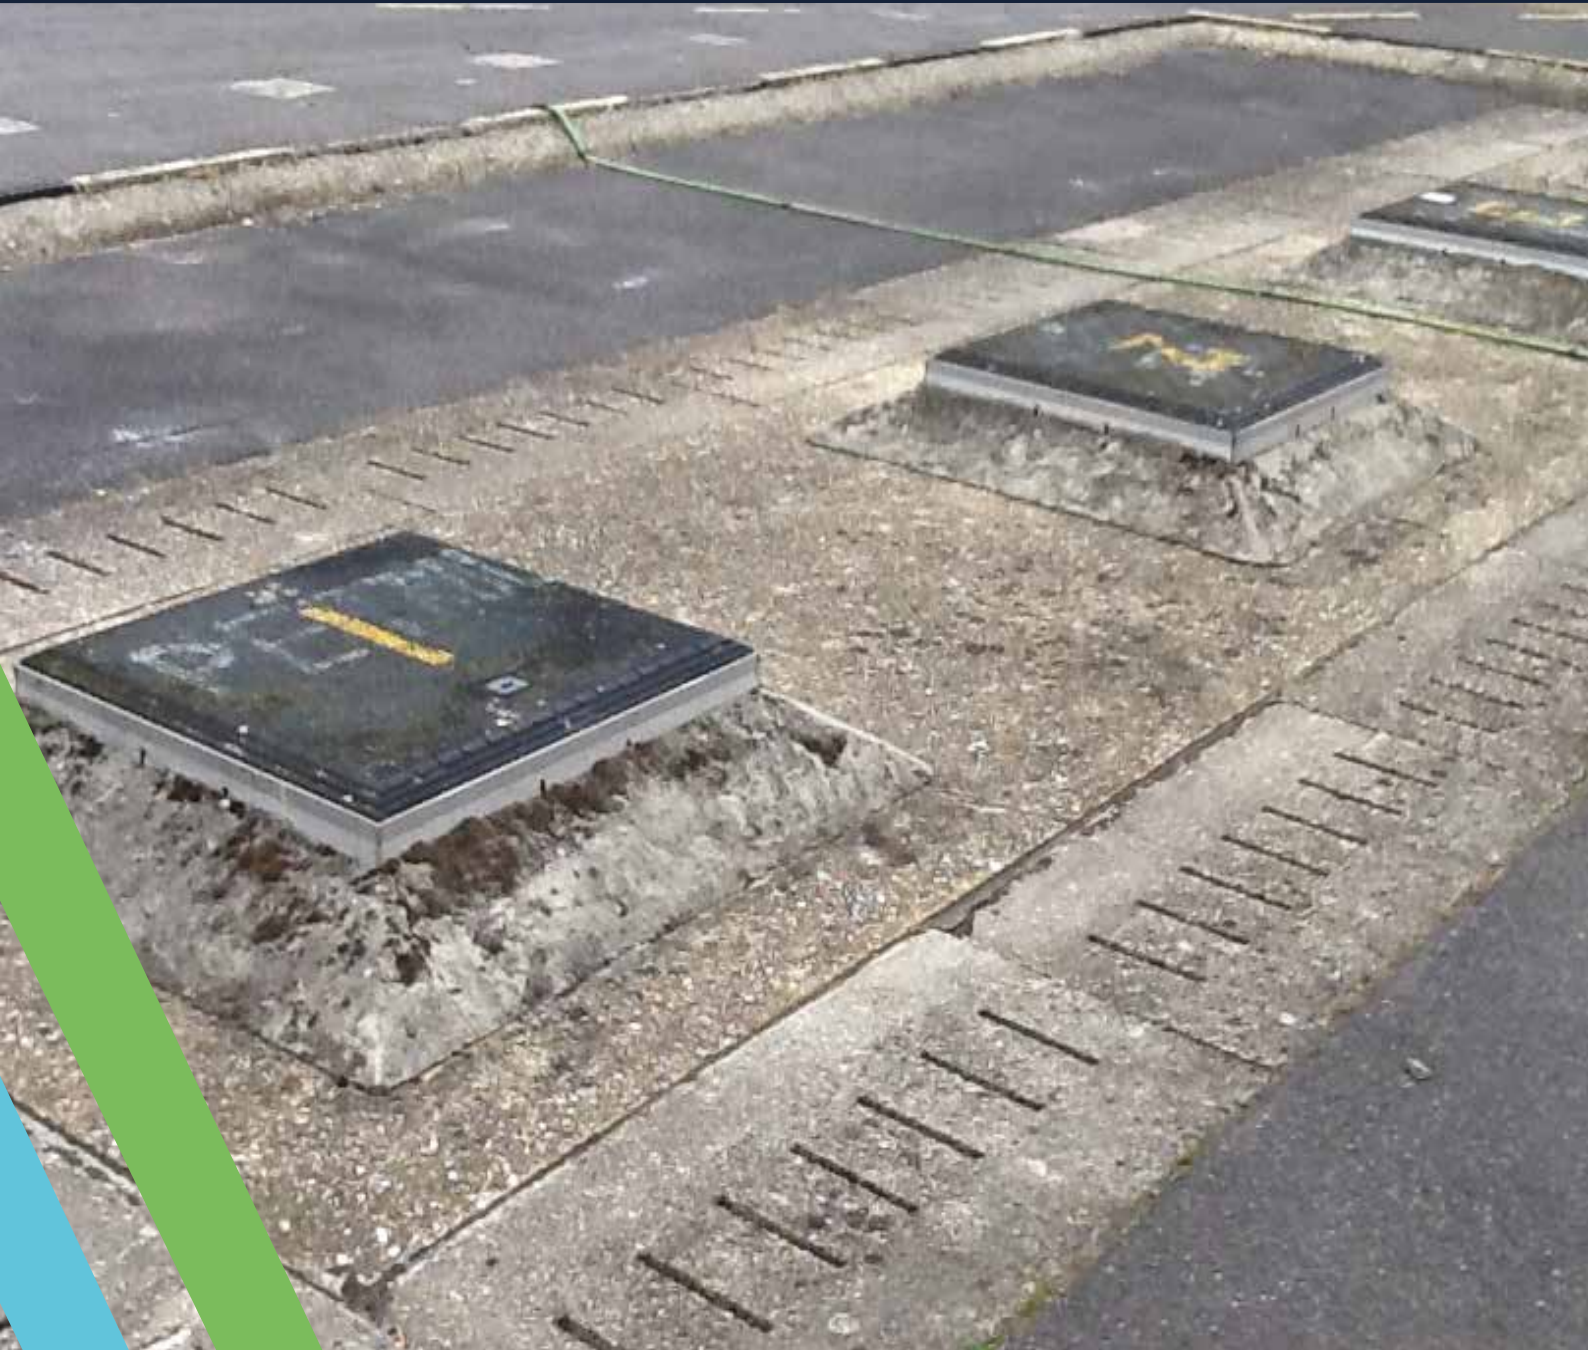
An MoD site on a garage fourcourt has fuel manway lids that go to four fuel tanks. These tanks are surrounded by concrete.

With time and high water table, the tanks move up and down slightly breaking the seals between the top of the tank and the manway chamber, causing water ingress.

Glass Reinforced Plastic (GRP) walls were fixed to poor quality substrate and sealed with soft joints from the base of the walls to the top of the fuel tank. It was agreed to use the Adalline 400 multi spray system on 4 GRP walls and to spray 100mm on to the tank lid to make a permanent seal which would stop water ingress to the manway lid chamber.

The works were completed in August 2014 and the manway chambers are dry albeit for some condensation on the underside of the manyway lids.
