PAXCON BLAST MITIGATION

SPRAY APPLIED BOMB BLAST PROTECTION DEVELOPED BY LINE-X®

PAXCON® Blast Mitigation

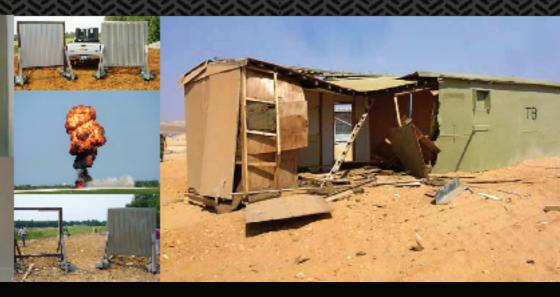
The PAXCON® coating strengthens these structures to be able to withstand potential bomb blasts. An example of a PAXCON® coated structure after a bomb blast can be seen on the top right side of this page (right side of structure marked 'TB' has the PAXCON® coating, left side of structure is uncoated.)

These structures, normally used during extended deployments, consist of timber stud walls, exterior aluminum coating and interior plywood paneling.
