Case Study

Protective Internal Tank Lining

RAF Marham

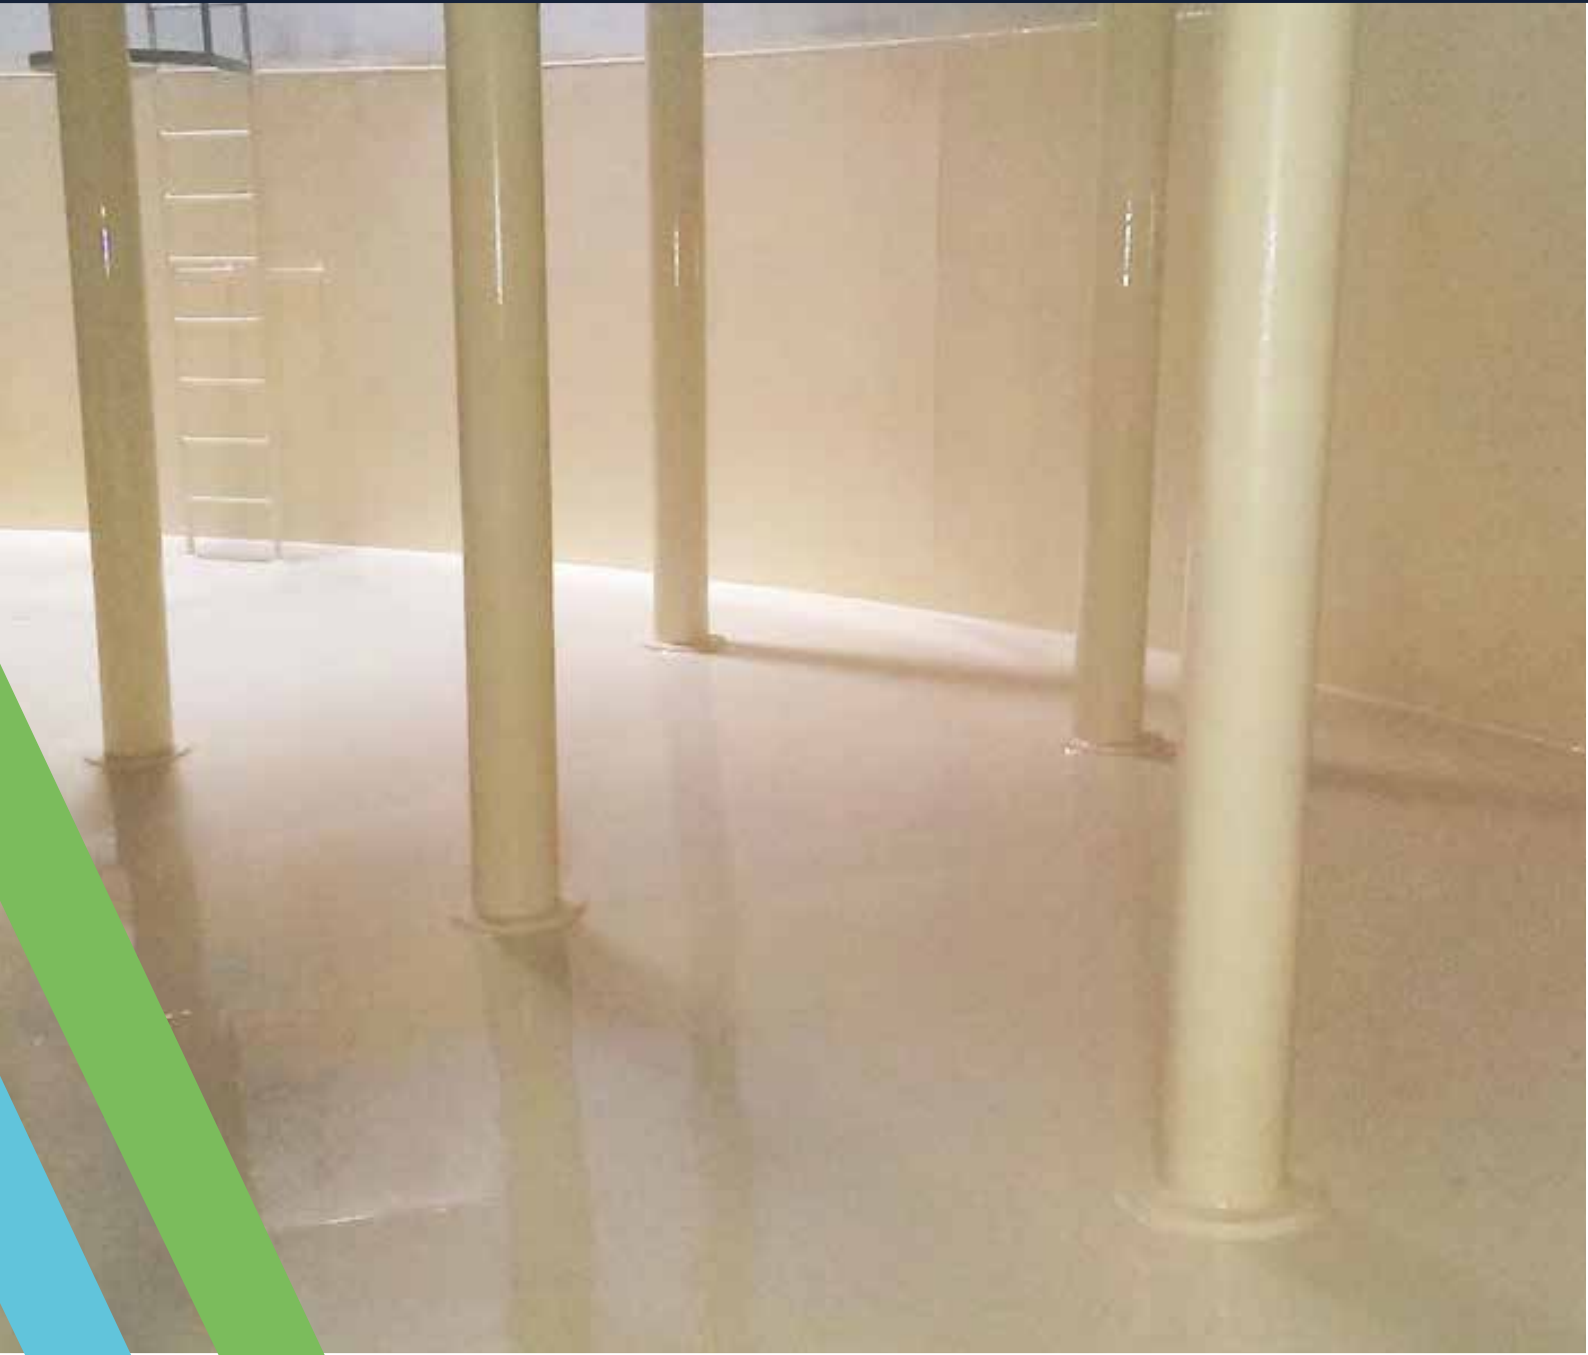
The tank is steel, encased in reinforced concrete and following an inspection it was identified that the internal tank casing, floor, first metre of shell and roof support columns all needed protecting.

The tank and supporting columns were coated in Interline 984, a solvent-free, epoxy phenolic lining system. Applied in a single coat, Interline 984 offers chemical resistance to a wide range of applications.

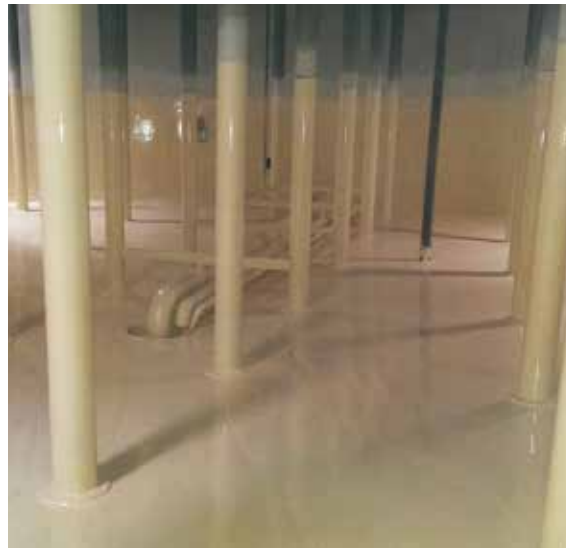
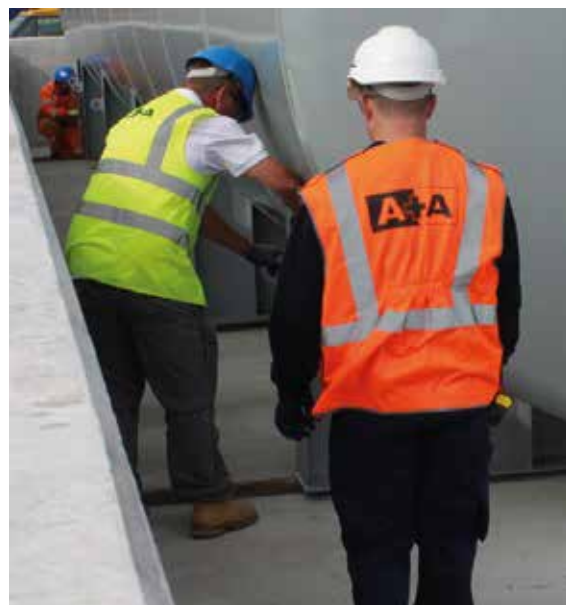
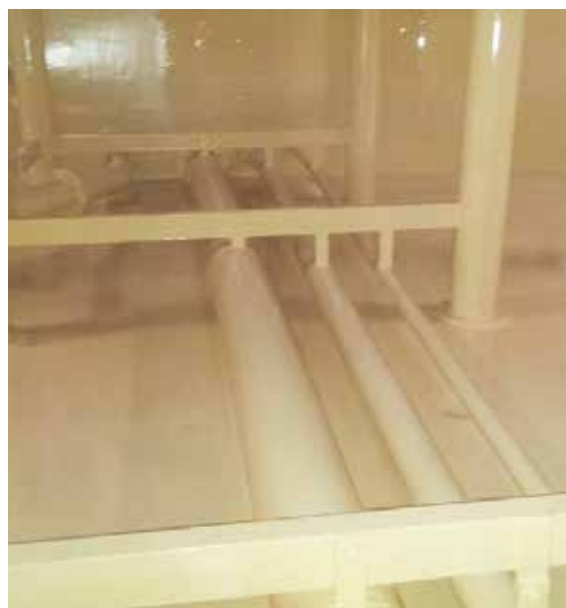
The project took six-weeks in total to complete, before and after the application of protective coating, the tank was cleaned thoroughly to ensure it was ready for use straight away.
